Canyon Fire Shelter Deployment and Entrapment Incident Review

CA-AFV-003151
Vandenberg Air Force Base, California
September 19, 2016

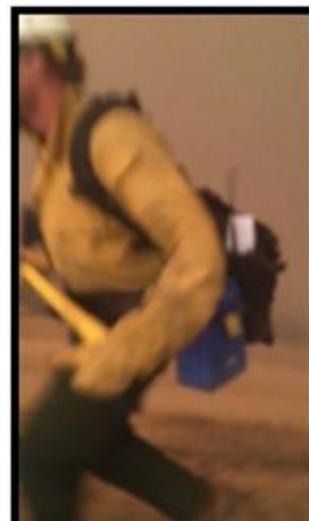
Screen grab from a firefighter’s video of a Helitack Module Crewmember running during the Division Zulu personnel’s escape to safety.

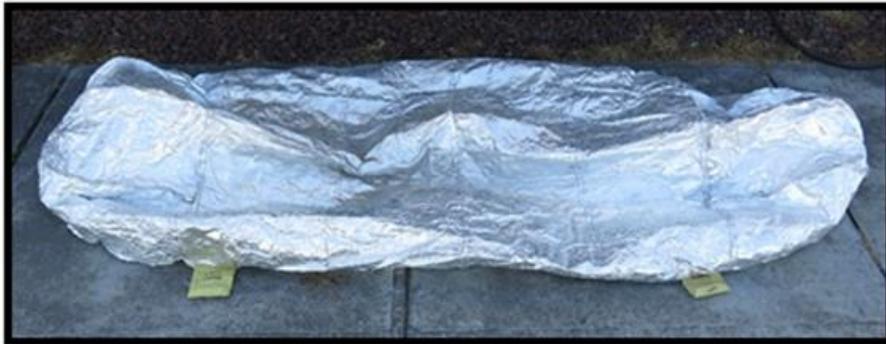
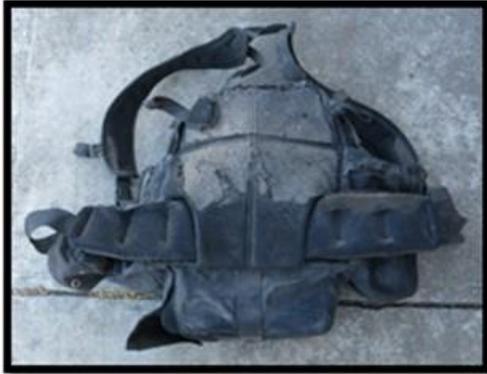
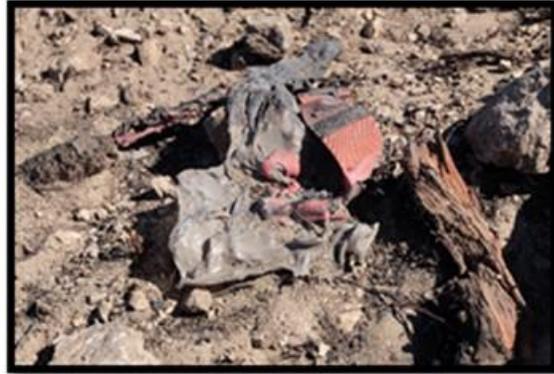
Engine Captain 253

- **Fire Shelter:** Manufacture Date – February 2014.
 - After the shelter was left at the deployment site, it was reported that the shelter was being tossed around by the wind. Dozer 2 was able to hold the shelter in place with its blade.
 - Structural Condition: A few spots of extreme heat are present. The spots were likely caused by hot embers.
- **PVC Bag:** The bag was found at the shelter deployment site, it was mostly melted.
- **Fireline Pack:** Padding cover melted.

Escape – When directed to go back to the safety zone, Captain 253 wanted to ensure that all engines got the word. He stopped at every engine he came to and told them to turn around and get back to the safety zone. Smoke and embers hit him hard. He attempted to keep pace with the Helitack Crew. It felt like the whole smoke plume came down on him. The smoke was so thick, he couldn't see his feet. The wind blew his helmet off. Keeping up with the Helitack Crew was unsuccessful.

Decision to Deploy – It was hot and very smoky. He couldn't see. He couldn't breathe. His legs quit moving. He felt he had to use his last option: His fire shelter.

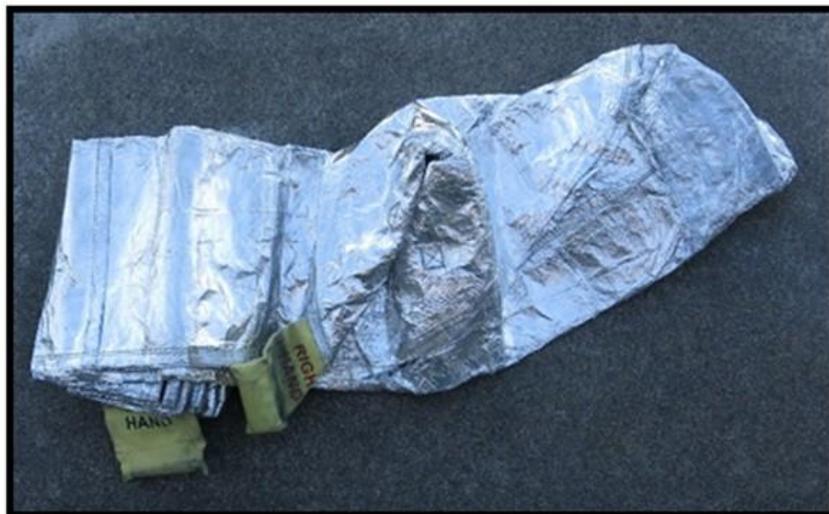
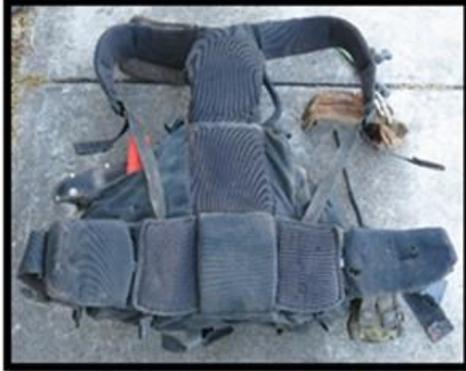
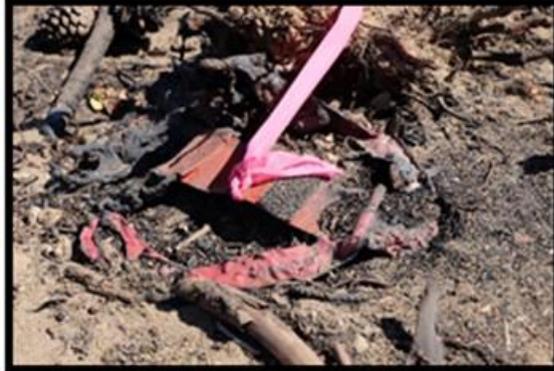
- **Fire Shelter:** The fire shelter was carried by the firefighter to the safety zone. It was mostly accordion folded.

- **PVC Bag:** The bag was found at the pack drop site, it was mostly melted.
- **Fireline Pack:** Numerous melt spots were present on the pack, most likely caused by hot ember contact during the entrapment.

Escape – The Helitack Crewmember began to move quickly as soon as they were told to get back to the safety zone. At first, the blowing smoke and embers would come and go. It was possible to get a good solid breath of fresh air every so often. Soon the pockets of good air stopped returning. He felt he couldn't see, so he tossed his sunglasses.

Decision to Deploy – More heat, smoke and embers came. All he could see was black and orange. He felt he was suffocating and couldn't continue to the safety zone. He tossed his tool, dropped his pack and grabbed his shelter. He didn't care about his water bottles or radio.

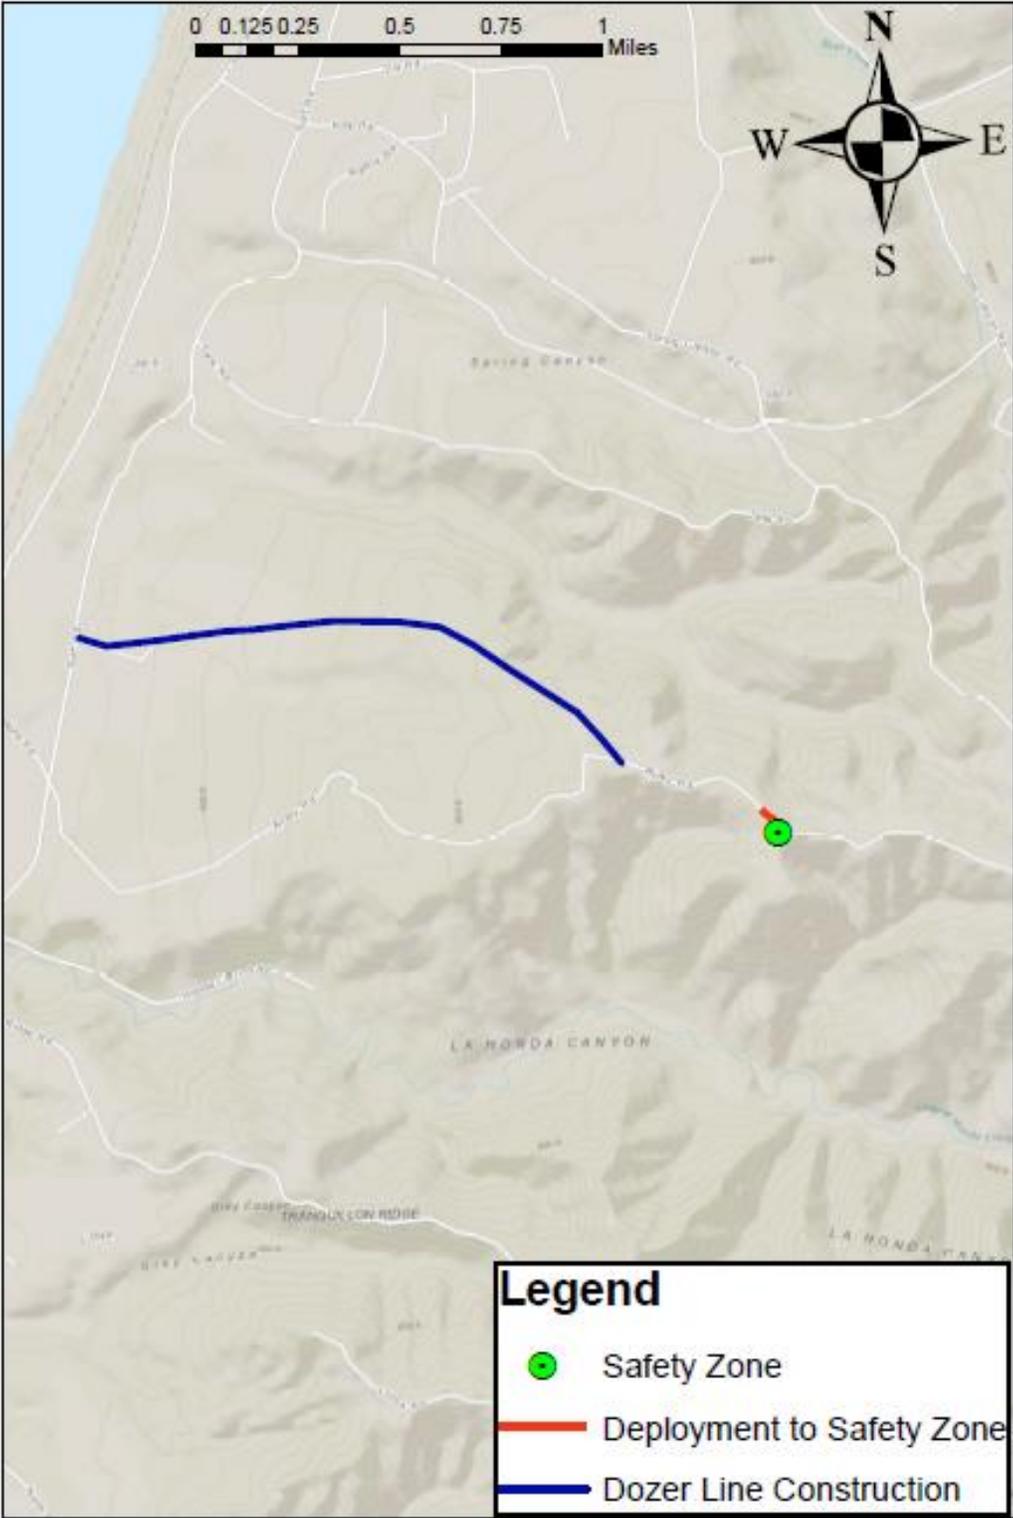
Map of Safety Zone, Dozer Line Construction, and Deployment Sites

- **Latitude x Longitude:** 34°36'42.81"N x 120°35'55.66"W
- **Elevation:** 1,025 feet.
- **Description:** The deployment sites were directly adjacent to Avery Road, 388 and 524 feet from the safety zone. The dozer widened the road to use it as control line. The majority of the south side of the road was black from the earlier burning operation. The north side of the road was considered green with 2 to 10-foot tall brush and small trees. Because the fire spread direction was to the north, the site received mostly radiant heat. Locations of all equipment was marked by flagging.

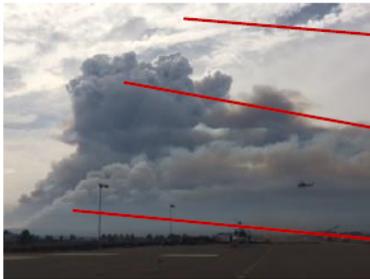
Smoke column exhibiting plume dominated characteristics. This would support the idea of an unstable atmosphere.
