Canyon Fire Shelter Deployment and Entrapment Incident Review

CA-AFV-003151
Vandenberg Air Force Base, California
September 19, 2016

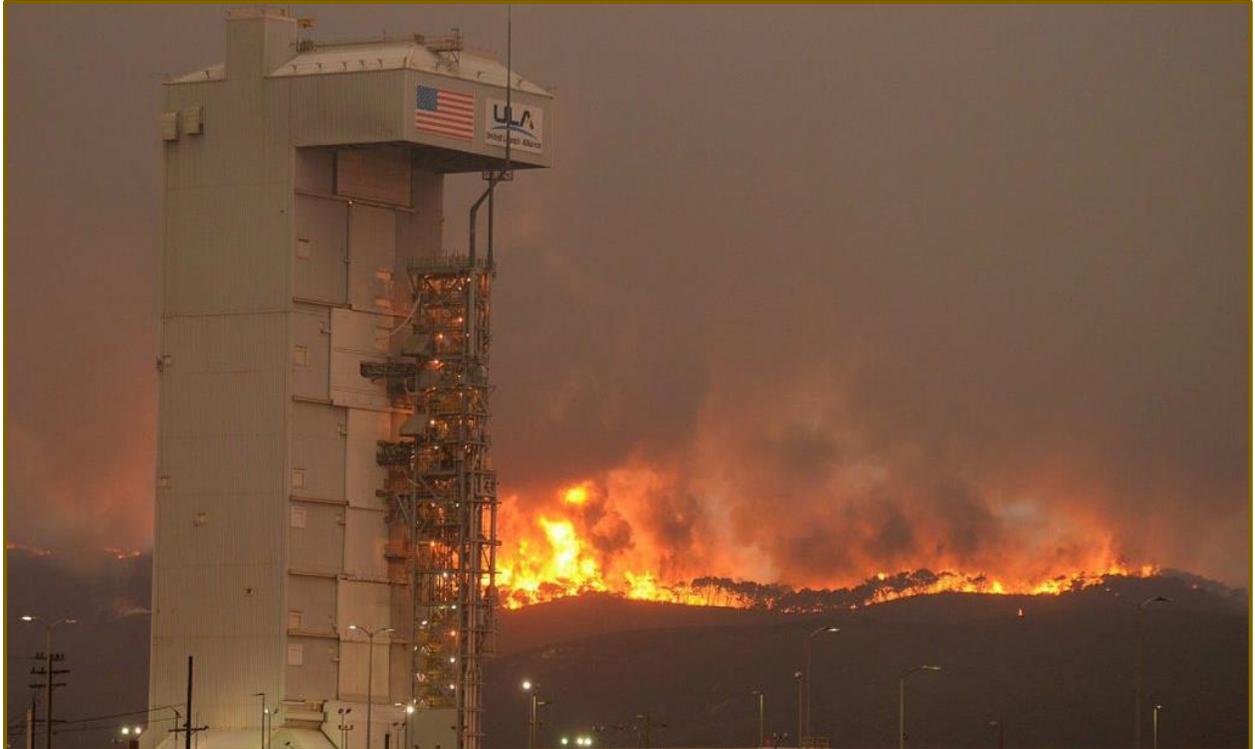
The Canyon Fire burning behind the Atlas 5 Rocket Pad on Vandenberg Air Force Base on Monday, Sept. 18, the day before the entrapment incident. Photo courtesy Santa Barbara County Fire Department.

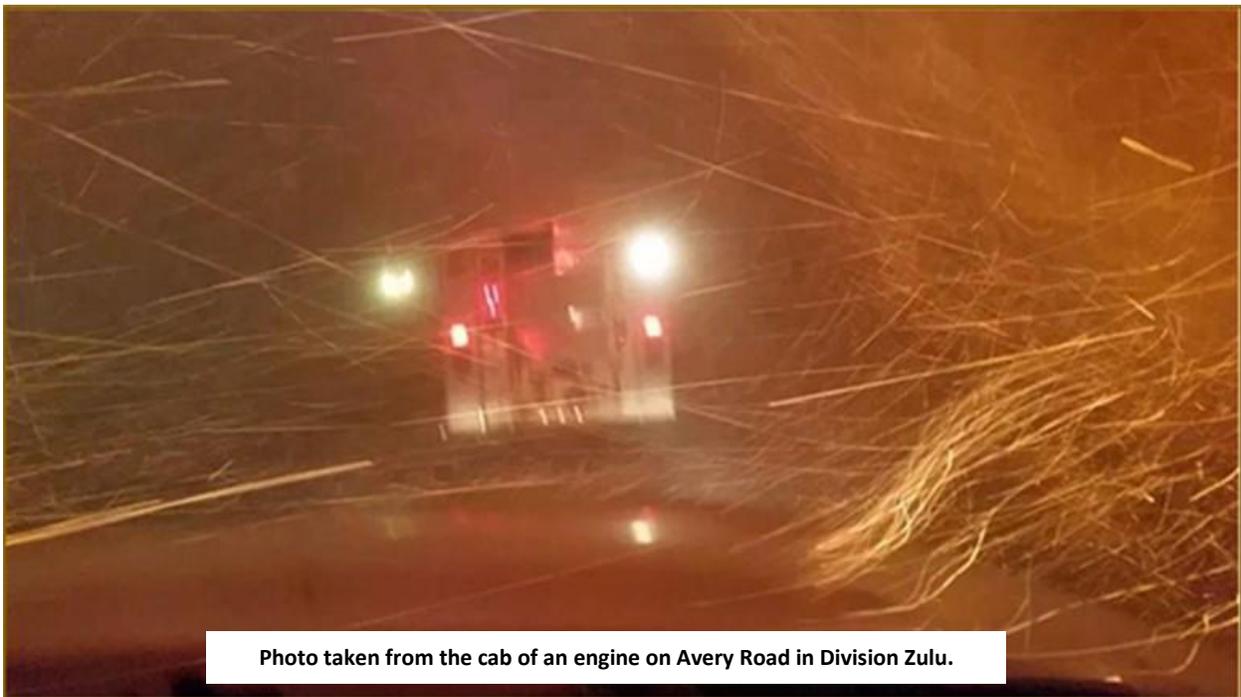
Photo taken from the cab of an engine on Avery Road in Division Zulu.
